# Fluvial geomorphological assessment for Stratford Extension Project EIS

Dr Christopher J Gippel  
For  
Stratford Coal Pty Ltd  
May 2012

**Stratford Extension Project Geotechnical Characterisation of CHPP Rejects [Allan  
Watson Associates, 2012]**

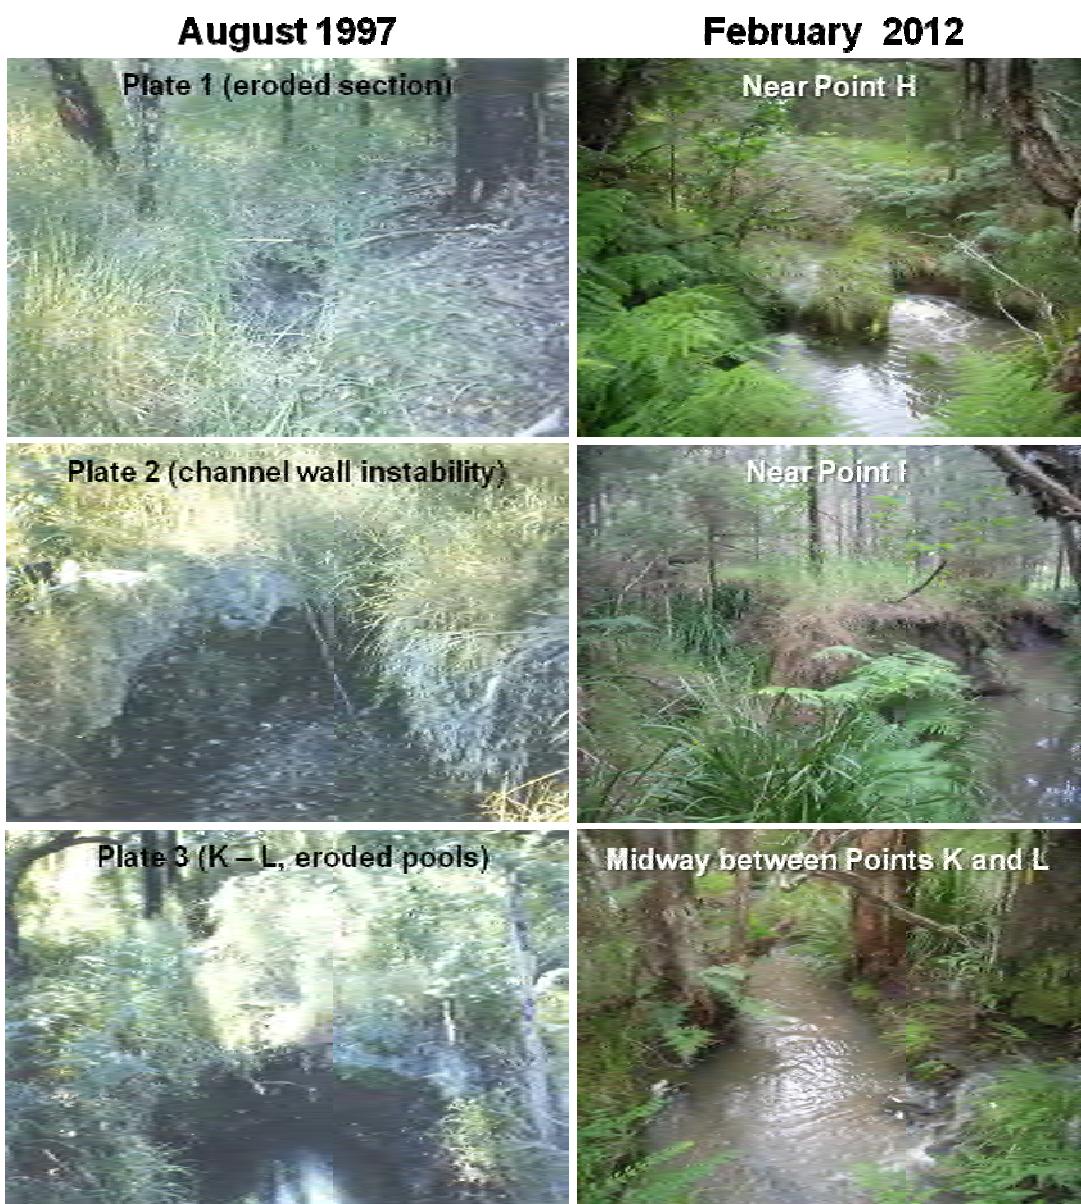
**Figure 7. Comparison of photographs (Plates 1 to 3) from Gilbert and Sutherland (1997) and those taken in 2012 from similar locations. Descriptions on 1997 photographs are from Gilbert and Sutherland (1997).**

Although Gilbert and Sutherland (1997) did not provide the exact locations of their photographs, photographs taken in 2012 in the same vicinities suggest that the creek had the same general character as it did in 1997 (Figure 7, Figure 8 and Figure 9). The only point where there was an apparent difference was Point Qa, where Gilbert and Sutherland (1997) observed erosion, and in 2012 this section was not eroded (Figure 8).

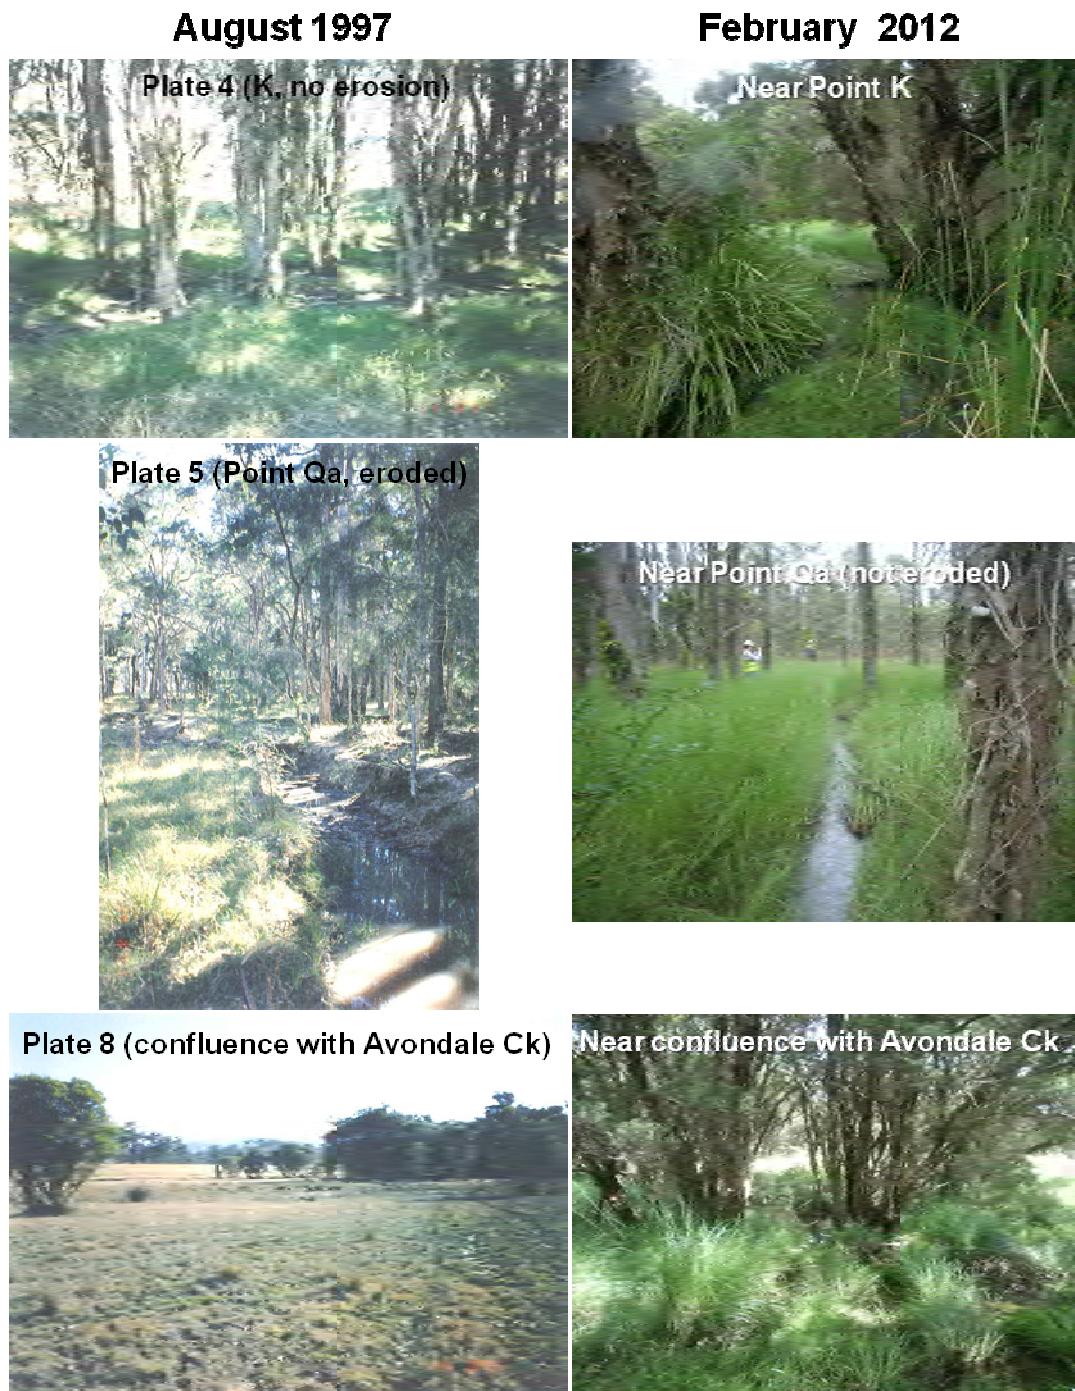
**Figure 8.** Comparison of photographs (Plates 4, 5 and 8) from Gilbert and Sutherland (1997) and those taken in 2012 from similar locations. Descriptions on 1997 photographs are from Gilbert and Sutherland (1997).

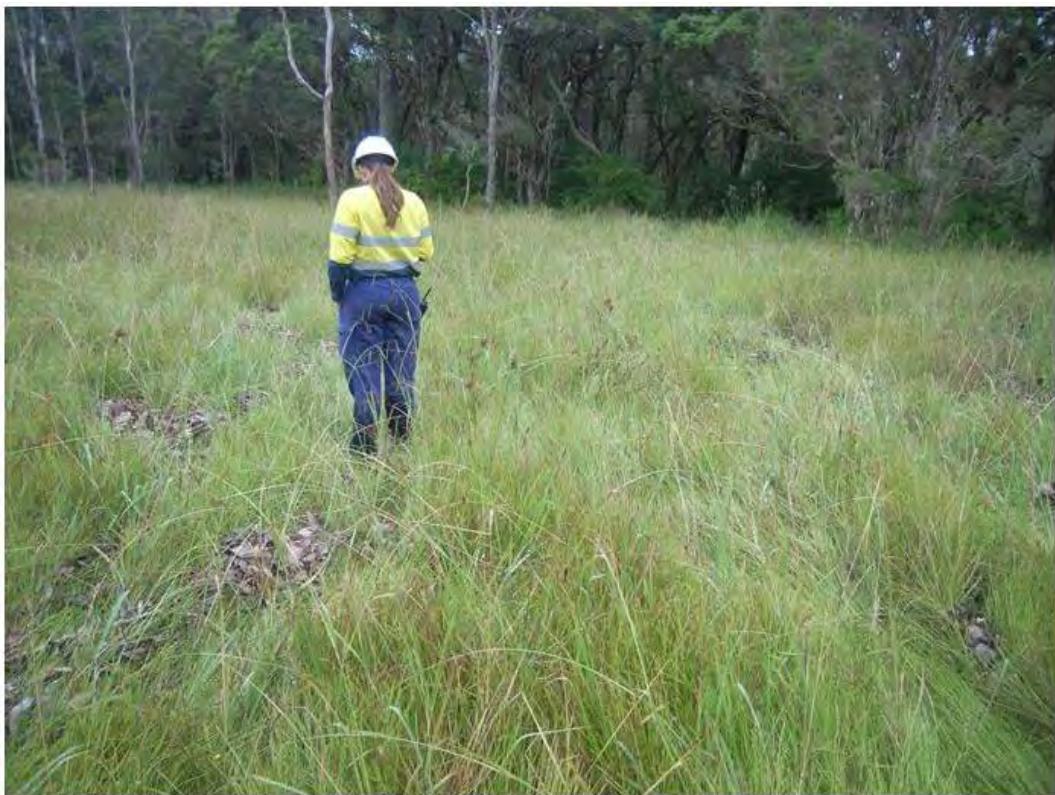
Figure 9. Point O on the map of Gilbert and Sutherland (1997), photographed in February 2012. In August 1997 this point was described as "...an area which appears to exhibit sheet flow across a wide area. No single defined channel is evident."

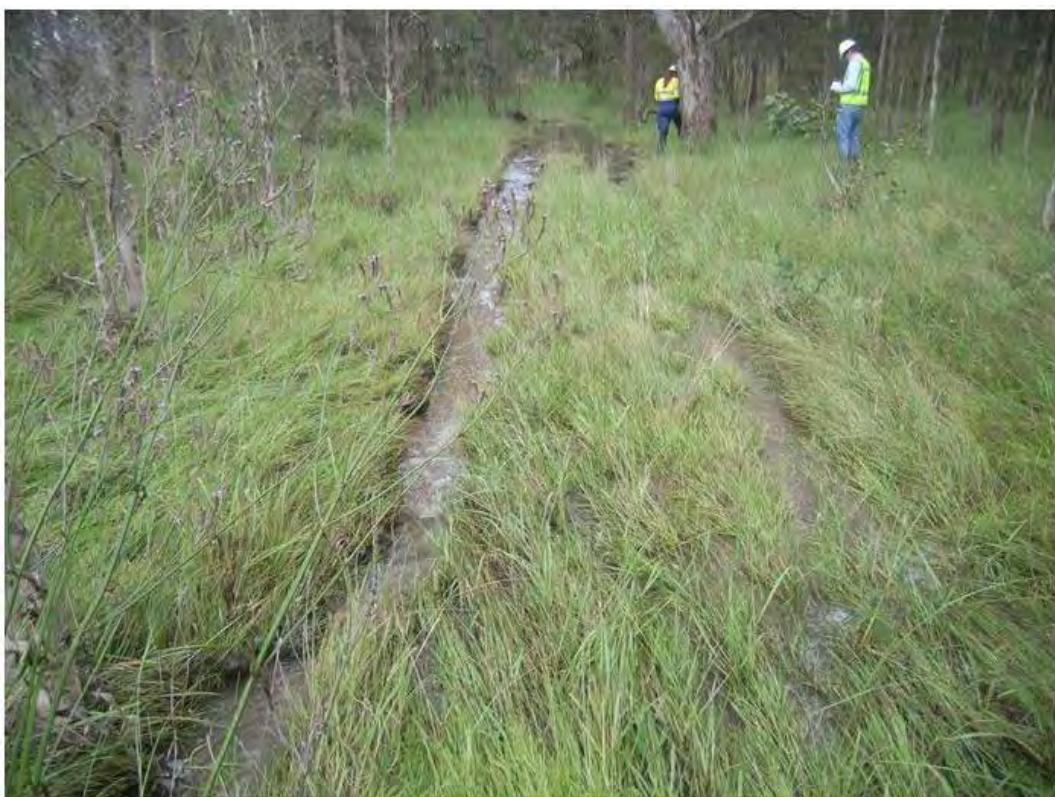
Figure 10. Midway between Points Qa and S on the map of Gilbert and Sutherland (1997), photographed in February 2012. Creek flows in wheel ruts that are not healing.

The section of creek between Points Qa and S on Figure 6 runs along the northern side of a bund, constructed after 1997. The drainage runs along vehicle wheel tracks, which in places are rutted (Figure 10).

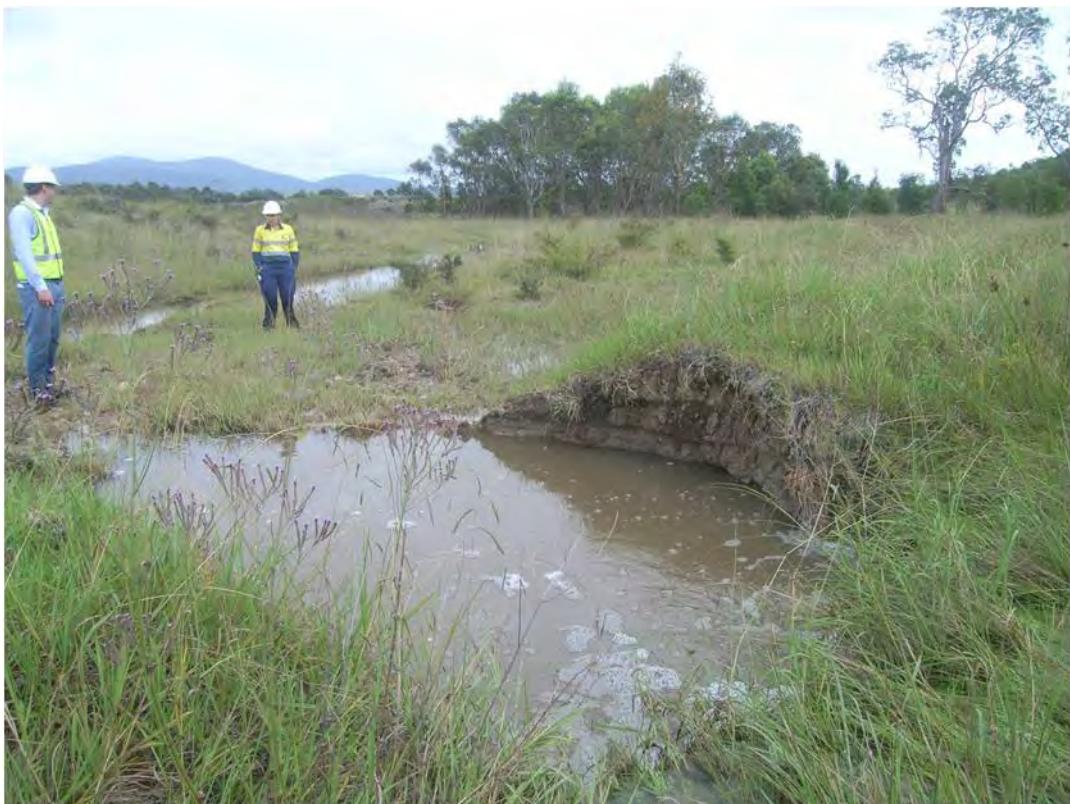
Figure 11. Just upstream of Point S on the map of Gilbert and Sutherland (1997), near the outlet of the sediment dam, photographed in February 2012. The bund has eroded, allowing the creek to flow south of the bund.

Just downstream of the sediment dam outlet, the bund has eroded (Figure 11) allowing the creek to flow south of the bund, although this appears to be inconsequential in terms of channel stability.

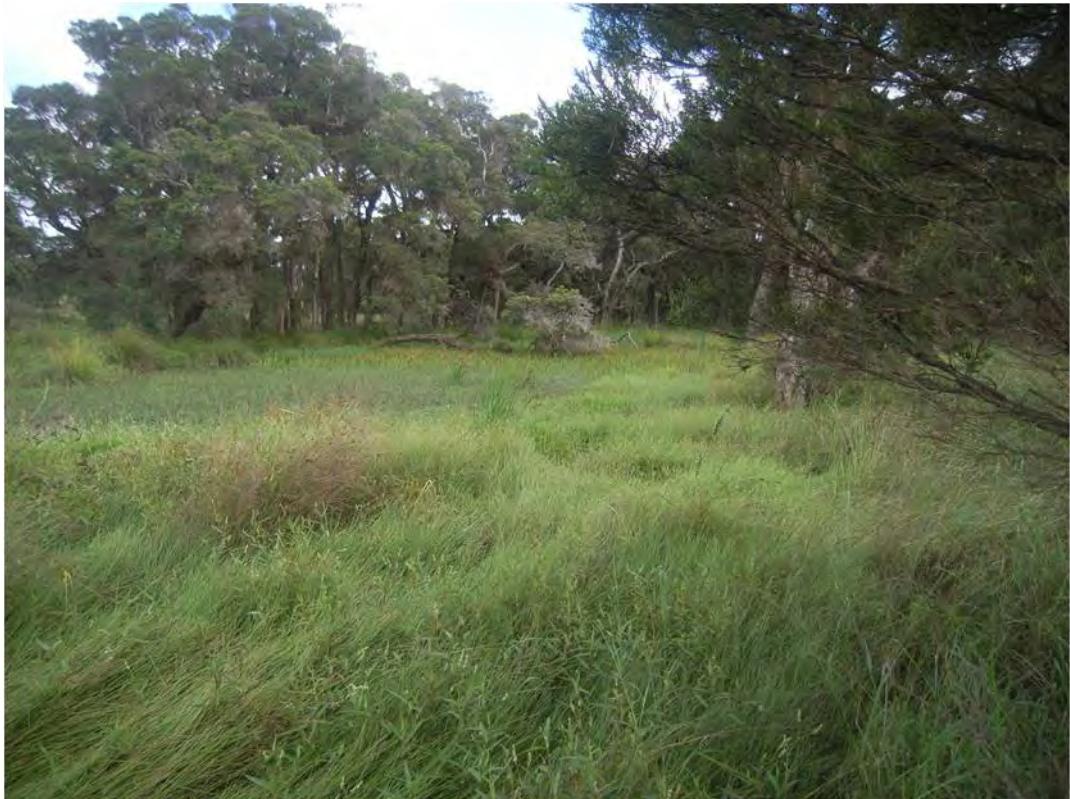
Figure 12. The unnamed tributary of Avondale Creek, 100 m upstream of its confluence with Avondale Creek, photographed in February 2012.

The section of creek from the culvert under the haul road to the junction of Avondale Creek is a very low gradient wetland area, with multiple shallow flow paths and pools present. The creek here is very well vegetated and stable (Figure 12).
